INDOOR AIR QUALITY ASSESSMENT

**John F. Kennedy Middle School
100 Bridge Road
Village of Florence
Northampton, MA 01062**

Prepared by:
Massachusetts Department of Public Health
Center for Environmental Health
Emergency Response/Indoor Air Quality Program
March 2006

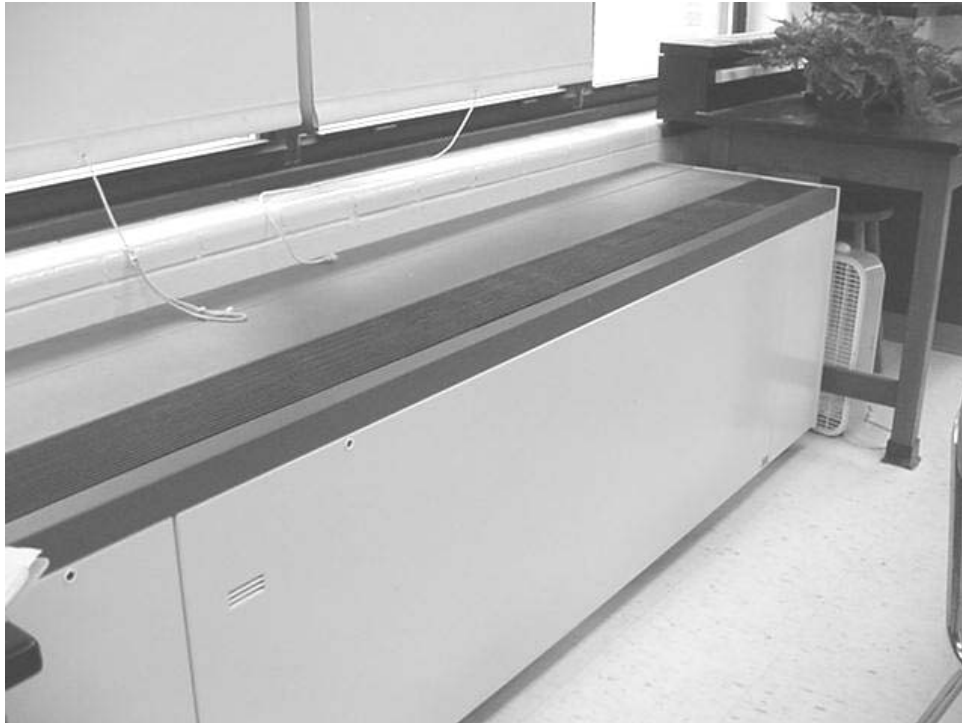
Picture 1

Approximately half of the classrooms surveyed had univents (Picture 1). A univent draws air from outdoors through a fresh air intake located on the exterior wall of the building (Picture 2) and returns air through an air intake located at the base of the unit ([Figure 1](#)). Fresh and return air are mixed, filtered, heated and provided to classrooms through a diffuser located on the top of the unit. Adjustable louvers control the ratio of

Classroom Univent

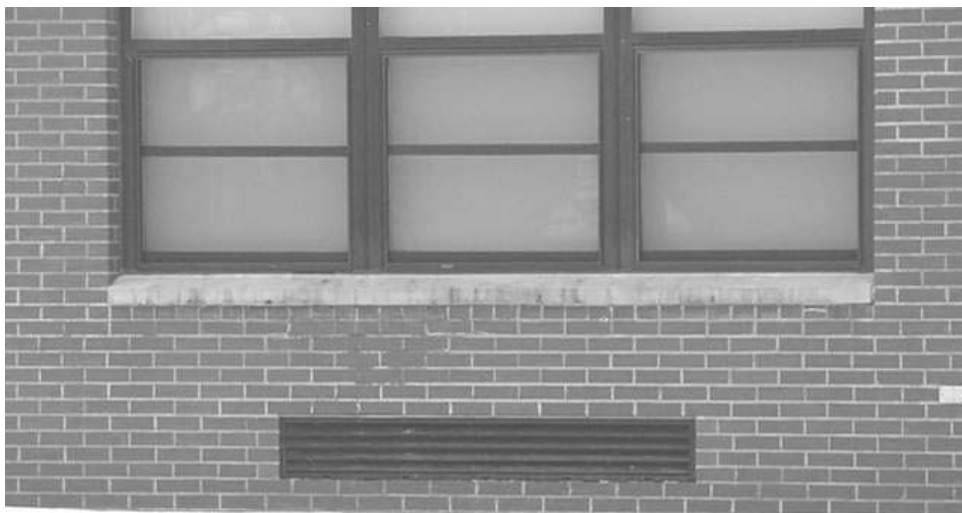
Picture 2

Univent fresh air intake

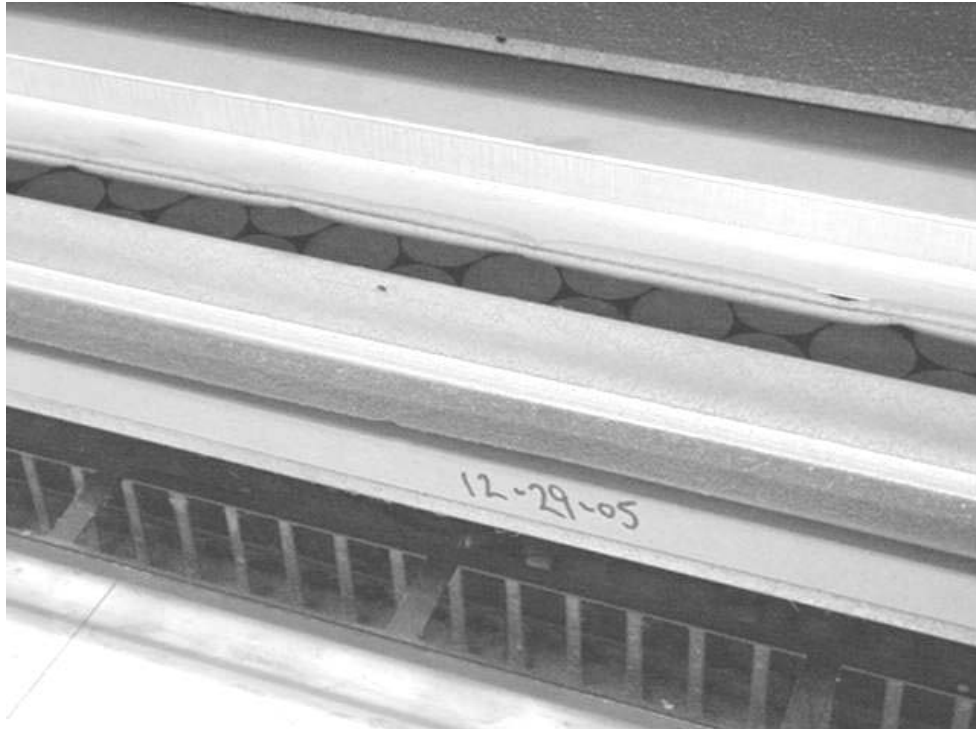
Picture 3

fresh and recirculated air. These univents are equipped with mesh filters that were last changed during winter break (Picture 3). Obstructions to airflow, such as furniture located in front of and/or materials stored on univents, were observed in some areas. Some univents were also deactivated at the time of assessment. In order for univents to provide fresh air as designed, these units must be activated and remain free of obstructions.

Mesh univent filters with replacement date

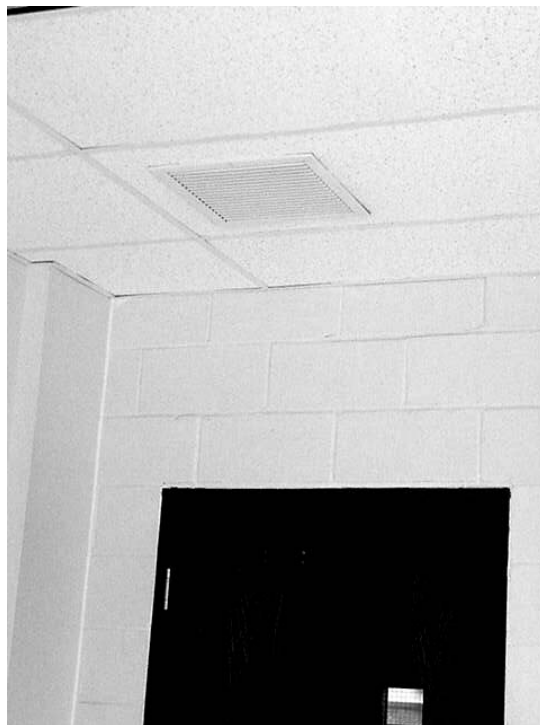
Picture 4

Mechanical exhaust ventilation for these areas is provided by ceiling- or wall-mounted vents connected to rooftop fans (Pictures 4 and 5). This system was operating, although weakly in some areas, during the assessment. It is important to note that the location of some exhaust vents can limit exhaust efficiency. In some classrooms, ceiling-mounted exhaust vents are located above hallway doors (Picture 4). When classroom doors are open, exhaust vents will tend to draw air from both the hallway and the classroom. The open hallway door reduces the effectiveness of the exhaust vent to remove common environmental pollutants from classrooms. In some instances, wall-mounted exhaust vents were obstructed by furniture (e.g., book cases, file cabinets). Such obstructions also reduce the capability of the exhaust system to remove common classroom pollutants.

Exhaust vent located near door to hallway

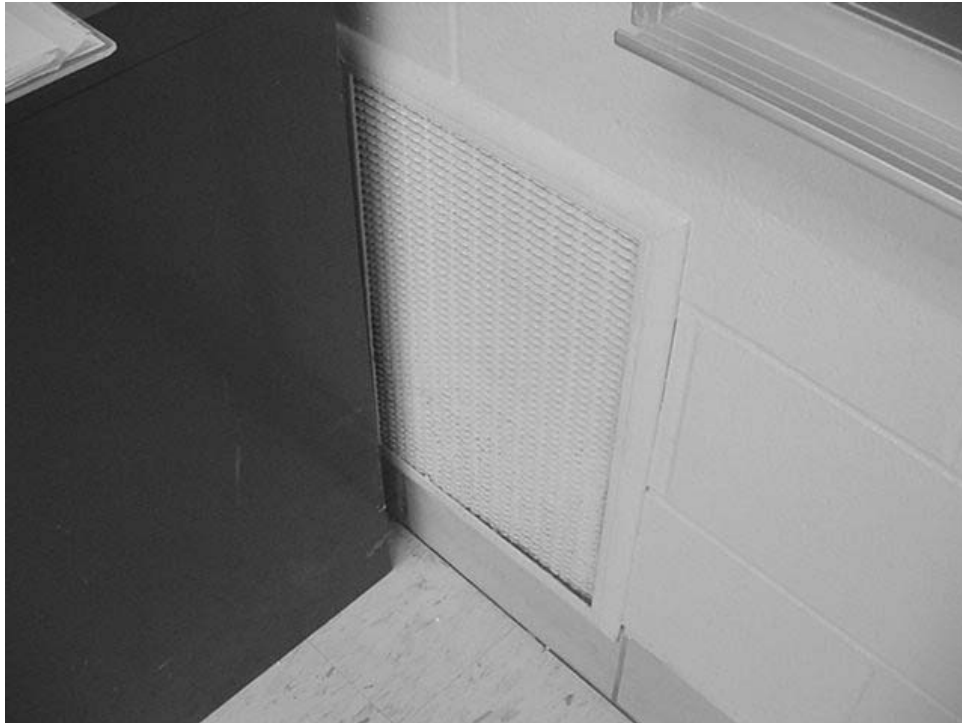
Picture 5

Wall exhaust partially obstructed by file cabinet

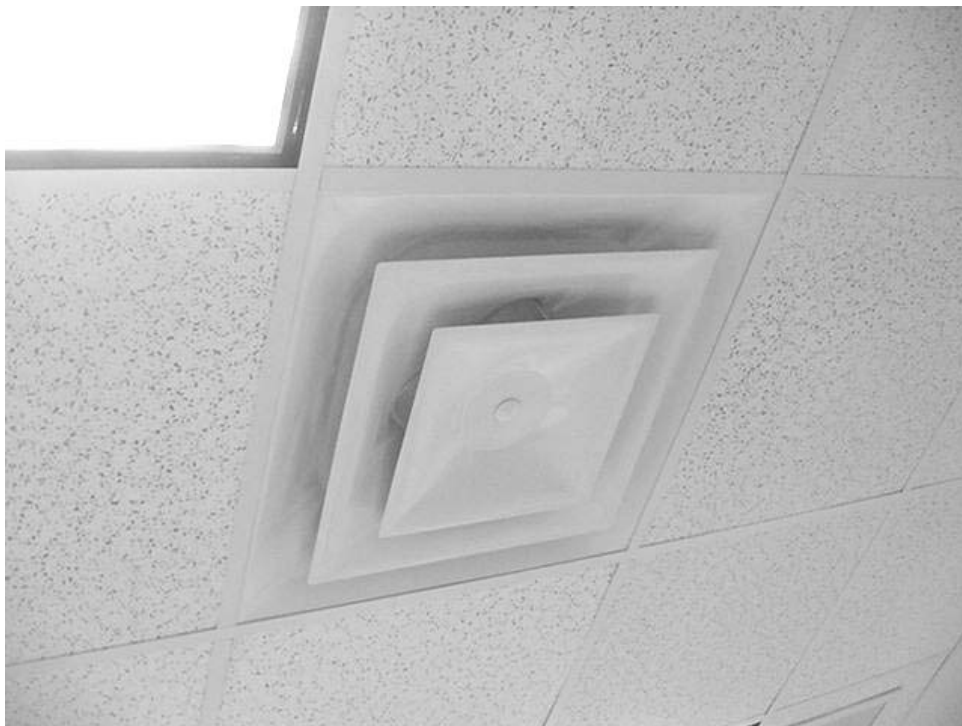
Picture 6

For the remainder of school areas, ventilation is provided by rooftop air handling units (AHUs). Fresh tempered air is supplied through ceiling mounted air diffusers (Picture 6) and ducted back to the AHUs via return vents (Picture 7). These AHUs have localized thermostats that allow a computer system to monitor and control the AHUs. At the time of the assessment, supply of air via the ceiling vents could not be detected. This may indicate that either the AHUs were off or that the units were set to 'automatic'. When an AHU's setting is programmed to automatic, the HVAC system's thermostat is set at a

Ceiling supply vent

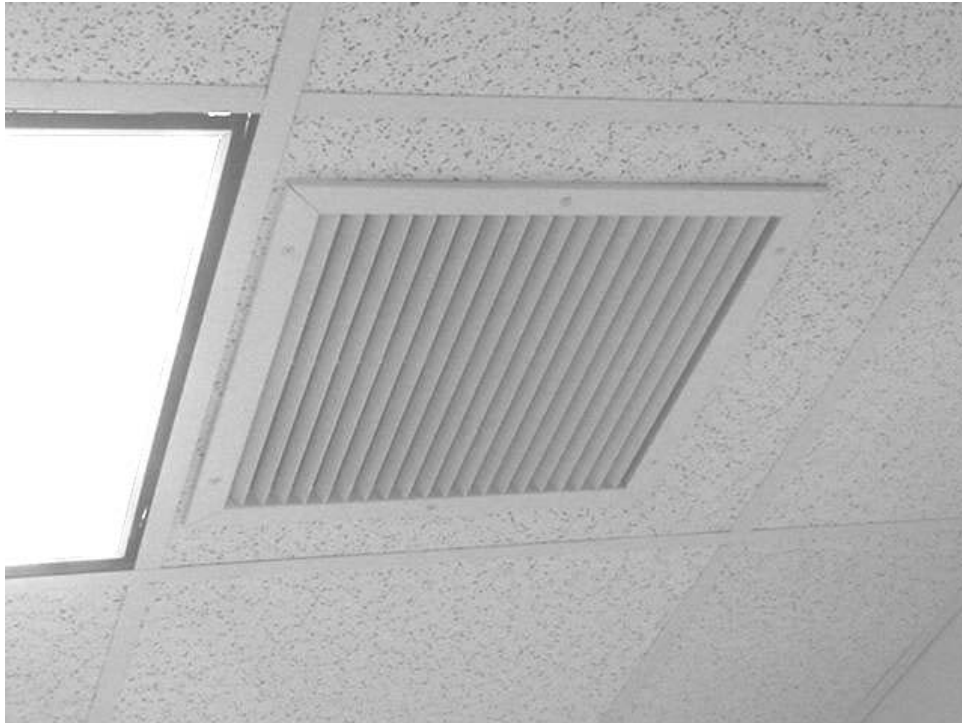
Picture 7

Ceiling-mounted return vent

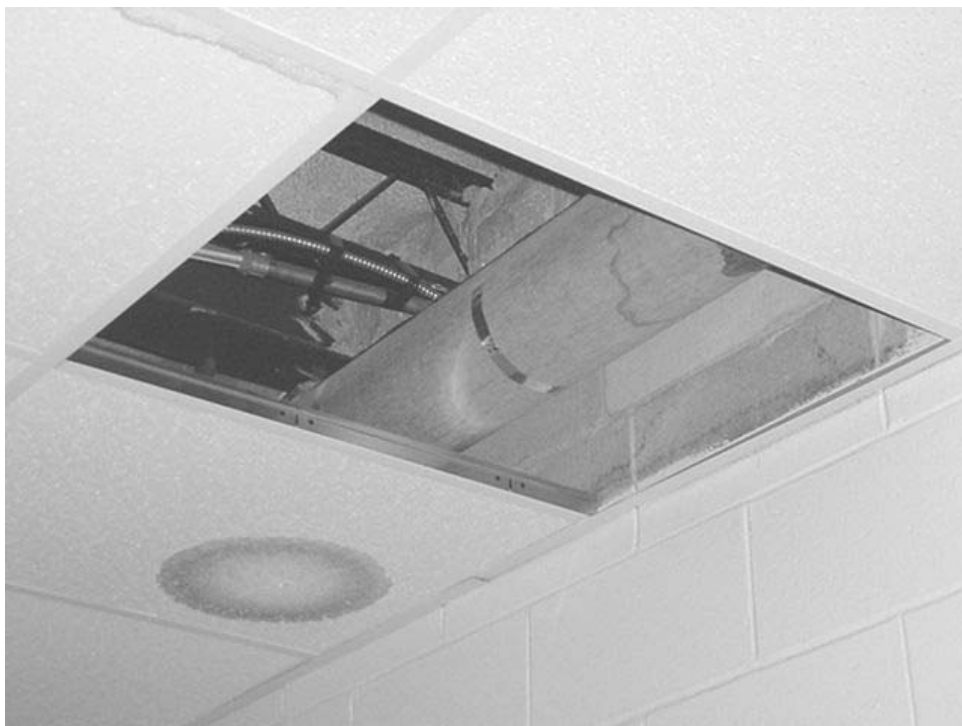
Picture 8

A few hallway areas had water-stained ceiling tiles (Picture 8), most likely from a roof or pipe leak. Water-damaged ceiling tiles can provide a source for mold and should be replaced after a water leak is discovered and repaired. Ceiling tiles in some areas had been removed after water damage occurred; replacement tiles were reportedly on order at the time of the assessment.

Missing and water damaged ceiling tiles in hallway

8. Ensure roof and/or plumbing leaks are repaired, and replace any water-stained/missing ceiling tiles. Examine the space above and around these areas for mold growth. Disinfect areas of water leaks with an appropriate antimicrobial.

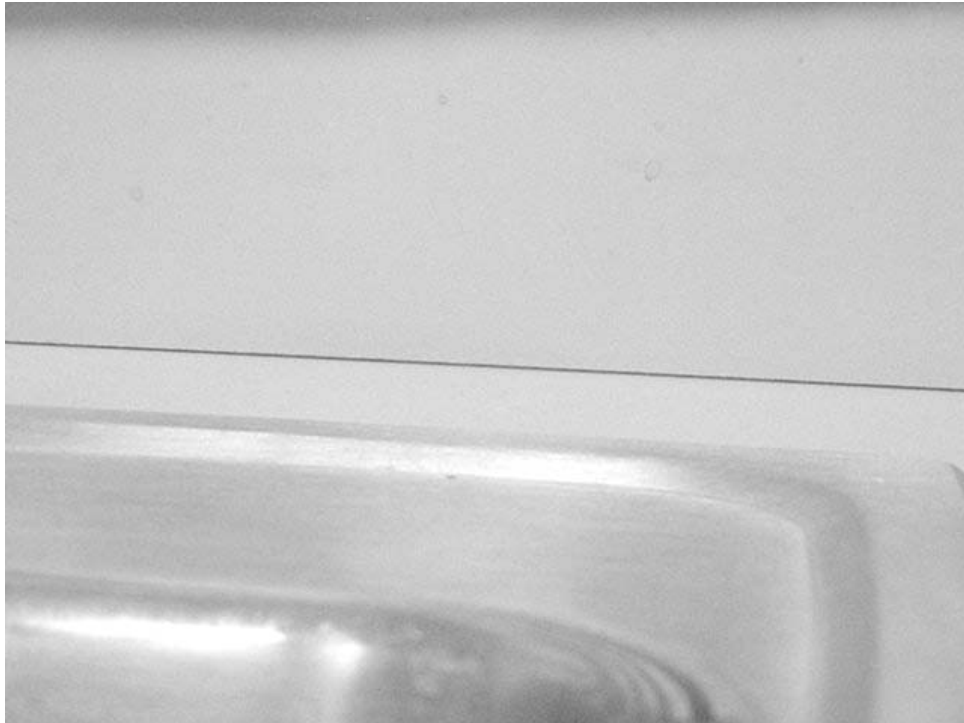
Picture 9

Open seams between the sink countertop and backsplash were observed in several rooms (Picture 9). If not watertight, water can penetrate through the seam, causing water

damage. Water penetration and chronic moisture exposure of porous and wood-based materials may lead to subsequent mold growth.

Breach between sink countertop and backsplash

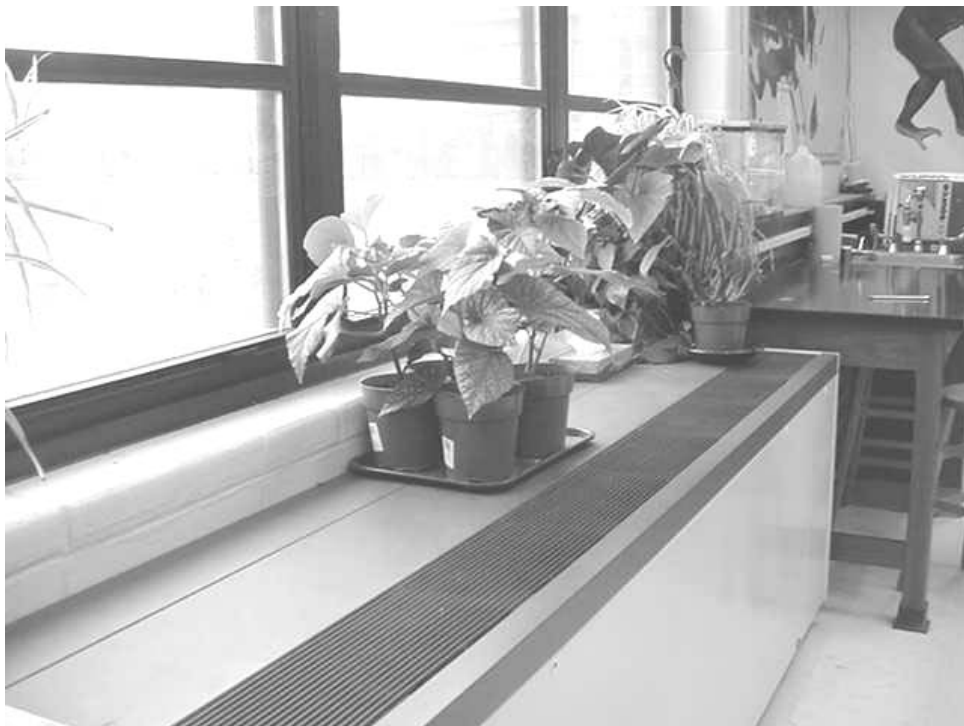
Picture 10

Plants were noted in several areas, with some placed on top of univents or near ventilation sources (Picture 10). Plants, soil and drip pans can serve as sources of mold growth and thus should be properly maintained. Plants should have drip pans to prevent wetting and potential mold growth on the surface of which it is placed. Drip pans should also be cleaned and maintained to prevent potential mold growth (Picture 11). Plants should also be located away from univents and ventilation sources to prevent aerosolization of dirt, pollen or mold.

Plants on univent

9. Move plants away from univents in classrooms. Ensure all plants are equipped with drip pans. Examine drip pans for mold growth and disinfect areas of water leaks with an appropriate antimicrobial where necessary.

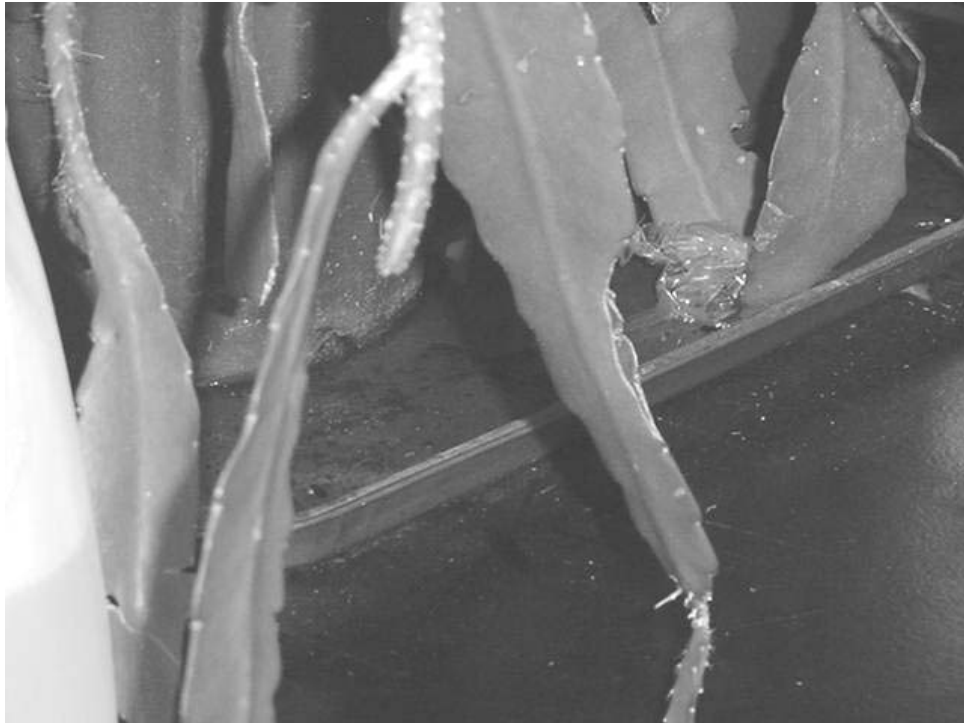
Picture 11

Plant drip pan, note debris and rust

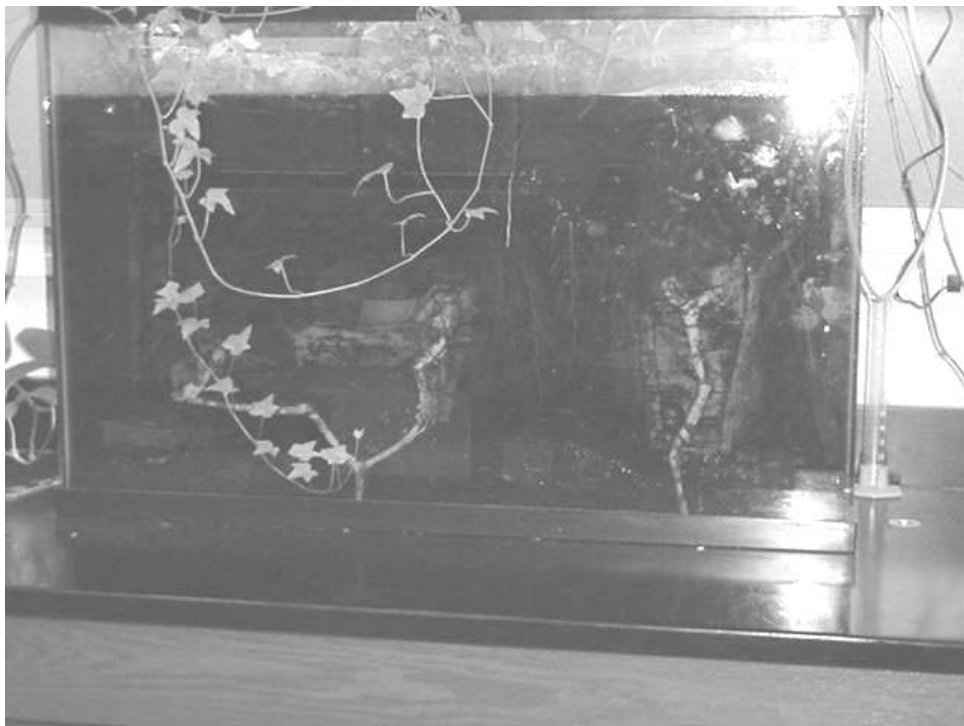
Picture 12

Several classrooms contained aquariums and terrariums (Picture 12). Aquariums should be properly maintained to prevent microbial/algae growth and unpleasant odors. Similarly, terrariums should be properly maintained to ensure soil does not become a source for mold growth and/or odors.

Aquarium, note turbidity of water

10. Clean and maintain aquariums and terrariums to prevent mold growth and associated odors.
11. Contact a masonry firm or general contractor to examine the building exterior to determine integrity of mortar.

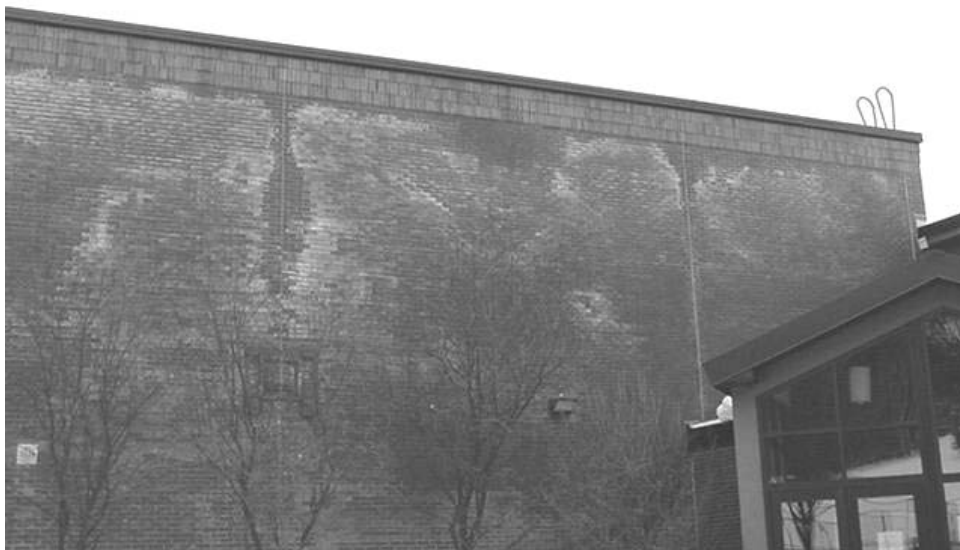
Picture 14

Evidence of efflorescence on the building exterior was observed (Picture 14). Efflorescence is a characteristic sign of water damage to brick and mortar, but it is not mold growth. As moisture penetrates and works its way through mortar and brick, water-soluble compounds in mortar and brick dissolve, creating a solution. As the solution moves to the surface of the mortar or brick, the water evaporates, leaving behind white, powdery mineral deposits. Over time, mortar can become damaged or missing, allowing water to penetrate the building. Since the building is of brick, concrete and metal construction, the building is also prone to condensation generation due to temperature differences between metal beams and materials in contact with the beams (Picture 15). As a result, cement and brick and mortar may be experiencing chronic moistening. As discussed, chronic moisture can result in damage to the building envelope and subsequent water penetration. Consideration should be given to examining the building exterior and, where necessary, repoint mortar and repair concrete.

Efflorescence on building exterior

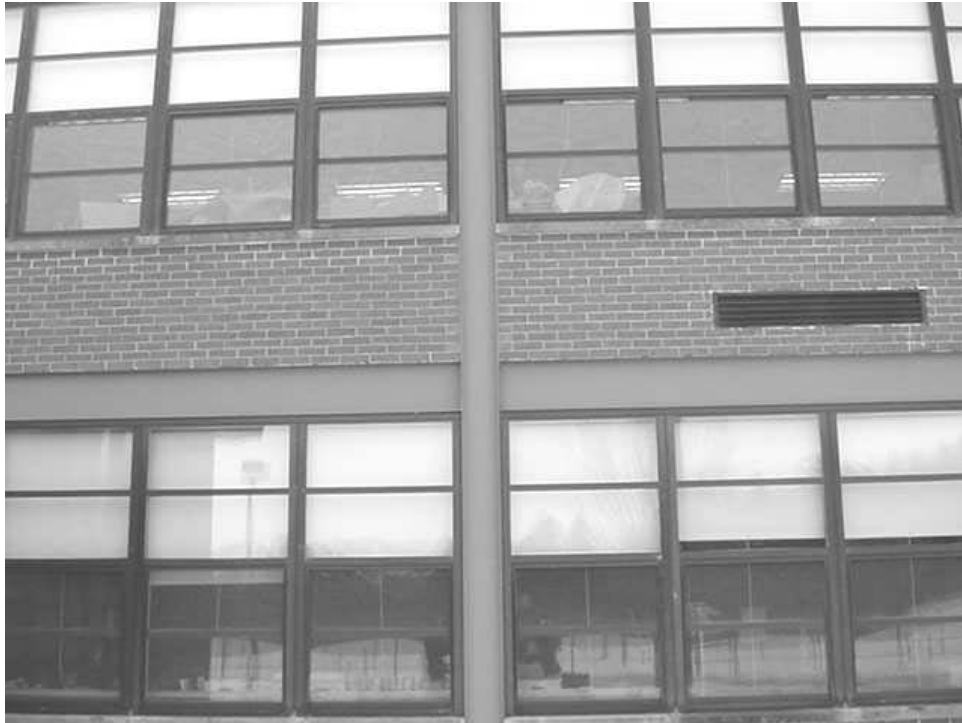
Picture 15

**Brick, cement and metal construction,
Note wet spots on cement slabs below metal window frames**

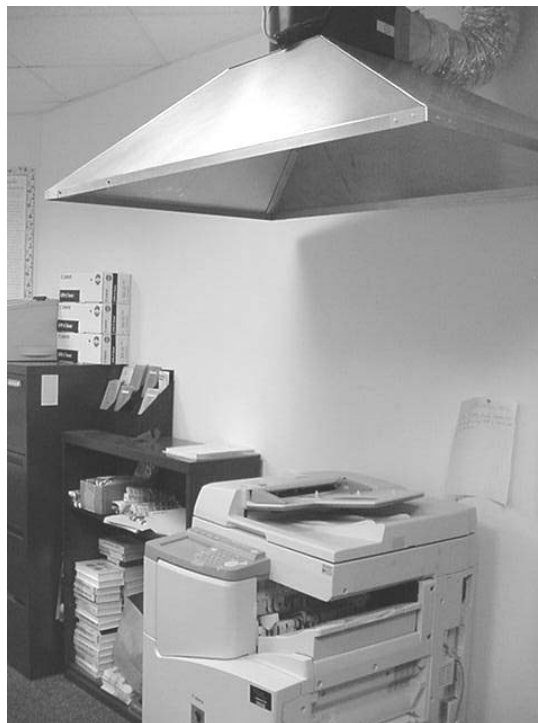
Picture 16

the Risograph[®], uses a liquid toner. Dedicated local exhaust ventilation was observed operating above all duplicating machines (Picture 16). Faculty and staff should ensure that local exhaust ventilation is operating when using equipment to ensure pollutants are being removed. Without operating exhaust ventilation, pollutants generated by duplicating equipment would accumulate in the occupant areas as duplication equipment is operating.

Dedicated exhaust for photocopier

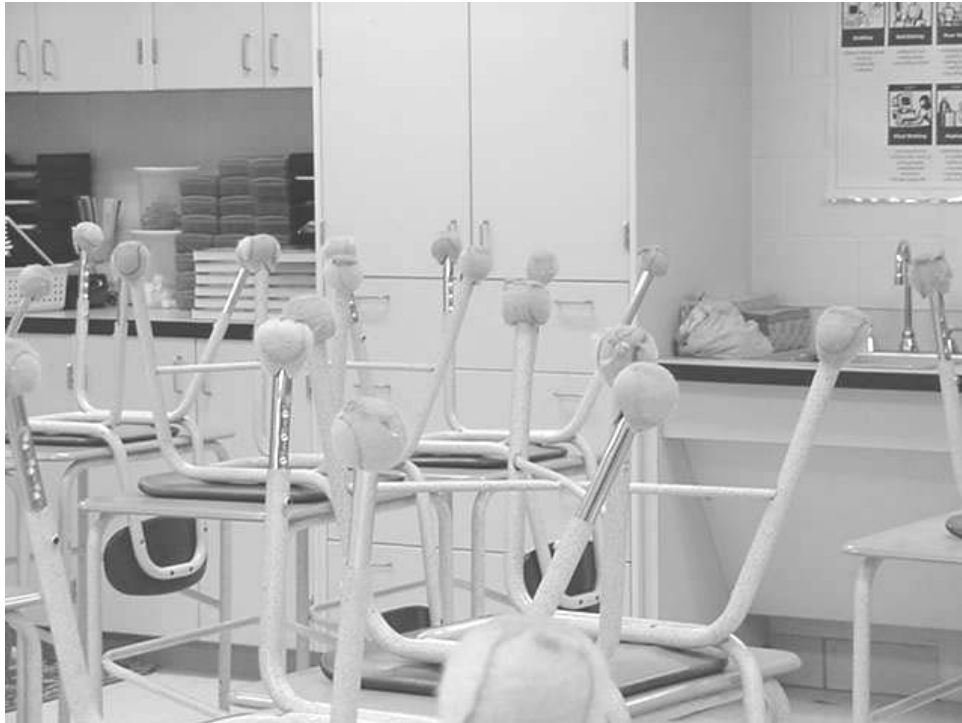
Picture 17

In an effort to reduce noise from sliding chairs, tennis balls had been spliced open and placed on chair legs (Picture 17). Tennis balls are made of a number of materials that are a source of respiratory irritants. Constant wearing of tennis balls can produce fibers and off gas VOCs. Tennis balls are made with a natural rubber latex bladder, which becomes abraded when used as a chair leg pad. Use of tennis balls in this manner may introduce latex dust into the school environment. Some individuals are highly allergic to latex (e.g., spina bifida patients) (SBAA, 2001). It is recommended that the use of materials containing latex be limited in buildings to reduce the likelihood of symptoms in sensitive individuals (NIOSH, 1997). A question and answer sheet concerning latex allergy is attached as [Appendix B](#) (NIOSH, 1998). School officials indicated that replacements similar to those depicted in Picture 18 were on order.

Tennis balls on chair legs

12. Repair/replace failing rubber gaskets in windows.
13. Continue with plans to replace tennis balls on chair legs with alternative glides.
14. Store cleaning products properly and out of reach of students.

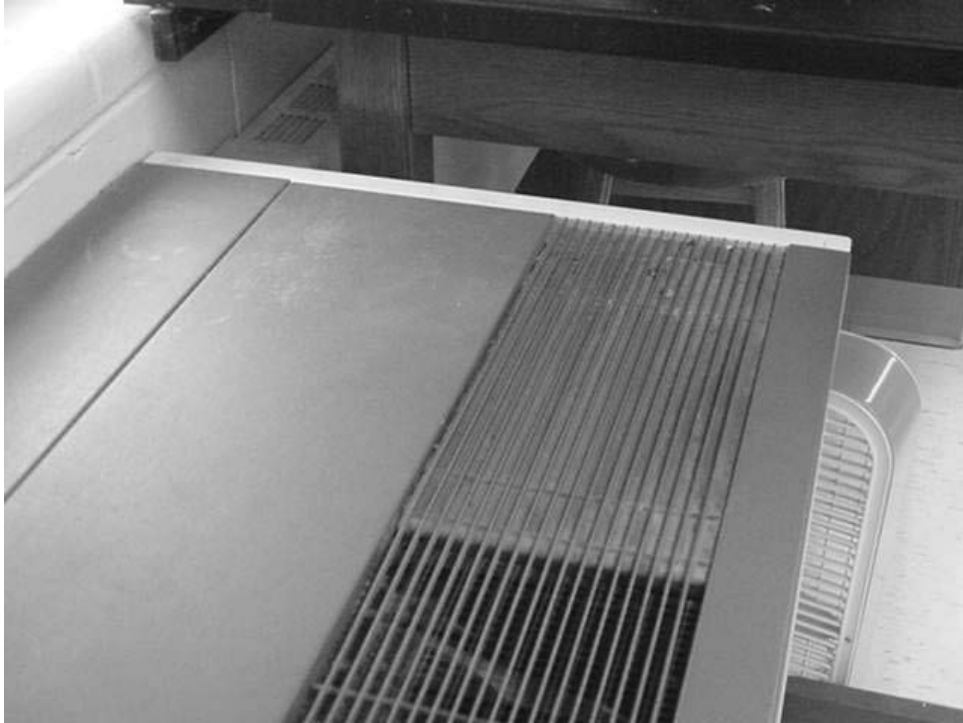
Picture 19

A number of exhaust/return vents, univent supply vents and personal fans had accumulated dust (Pictures 19 and 20). If exhaust vents are not functioning, back drafting can occur, which can re-aerosolize accumulated dust particles. Re-activated univents and fans can also aerosolize dust accumulated on vents/fan blades. It appears that a univent in the art area is being used to dry clay, papier-mâché and other art projects (Picture 21). Dust, particles and other materials from these projects can collect in the univent and be distributed. In addition, clays contain silicates which can become easily aerosolized and serve as eye and respiratory irritants. The Center for Occupation Hazards, located in New York City, recommends avoiding all procedures that create dust (COH, 1979). Several measures to avoid the accumulation of clay particles and other respirable dusts include wet mopping and wet wiping of horizontal surfaces (sweeping and dusting can stir up fine particulates) and use of a vacuum cleaner equipped with a high efficiency particulate arrestance (HEPA) filter to reduce the aerosolization of dust.

Accumulated dust in univent fresh air diffuser

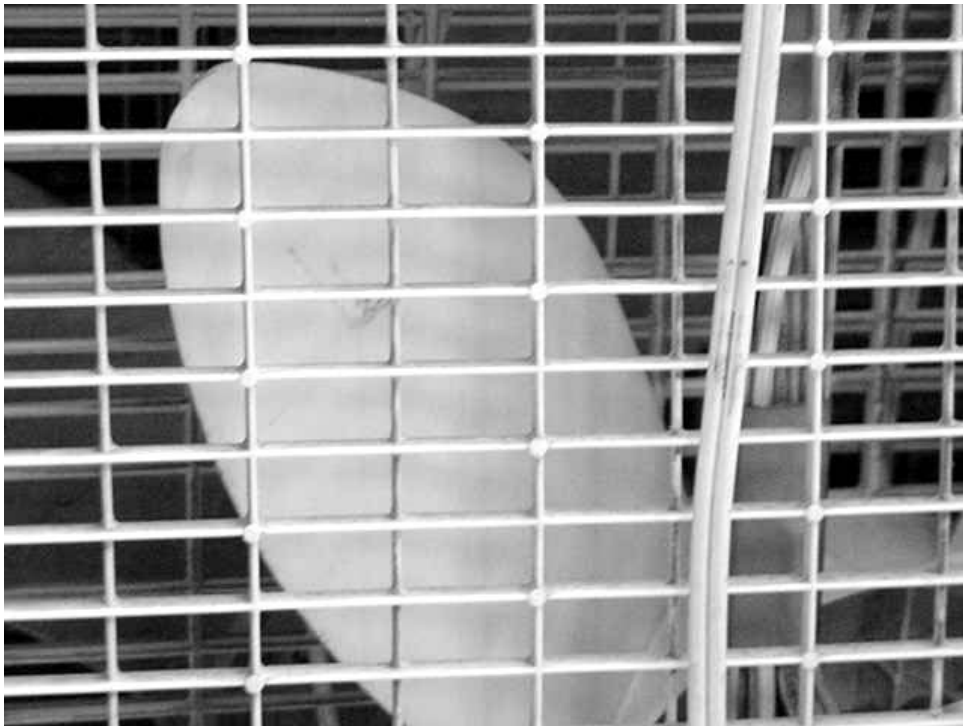
Picture 20

Dust accumulation on fan blades

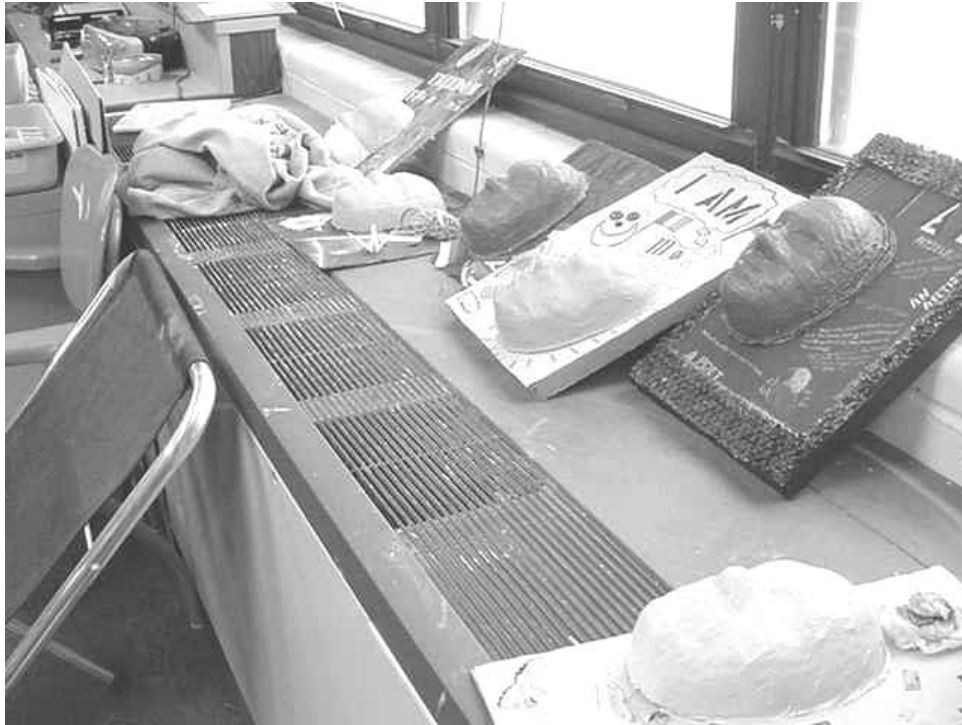
Picture 21

Items on univent, note materials adhered to diffuser

15. Relocate or consider reducing the amount of materials stored in classrooms to allow for more thorough cleaning. Clean items regularly with a wet cloth or sponge to prevent excessive dust build-up.

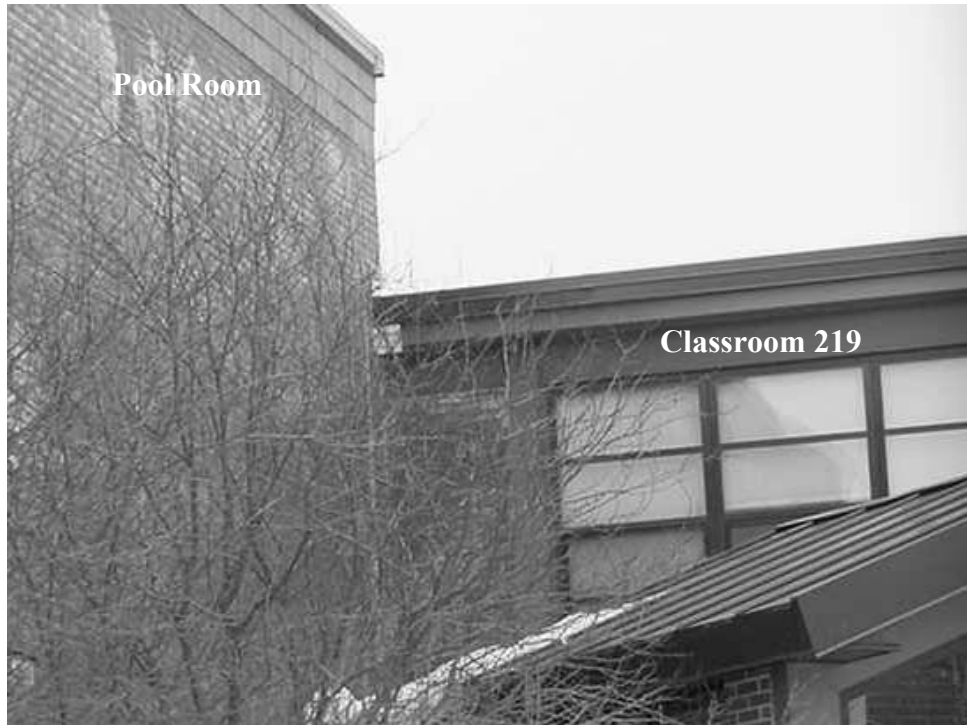
Picture 23

As previously discussed, pool odors (i.e., chlorine odors) were reported in a number of areas throughout the school. Odors are reportedly most notable in classroom 217, which is located on the second floor, adjacent to the indoor pool wing and stairwell (Picture 23). Pool odors are reportedly strongest on Monday mornings. This classroom has a univent system that, as with all HVAC equipment in the building, is turned off or operated at the minimum level over the weekends as a measure to conserve energy. As previously discussed, without operating ventilation equipment, indoor pollutants cannot be removed or diluted. Consideration should be given to operating ventilation equipment in this area, even during non-school hours. HVAC equipment to the pool should also be examined to ensure continuous operation at all times.

**Location of classroom 219 in relation to pool,
Note fresh air intake for classroom 219 is located behind peak of foyer roof**

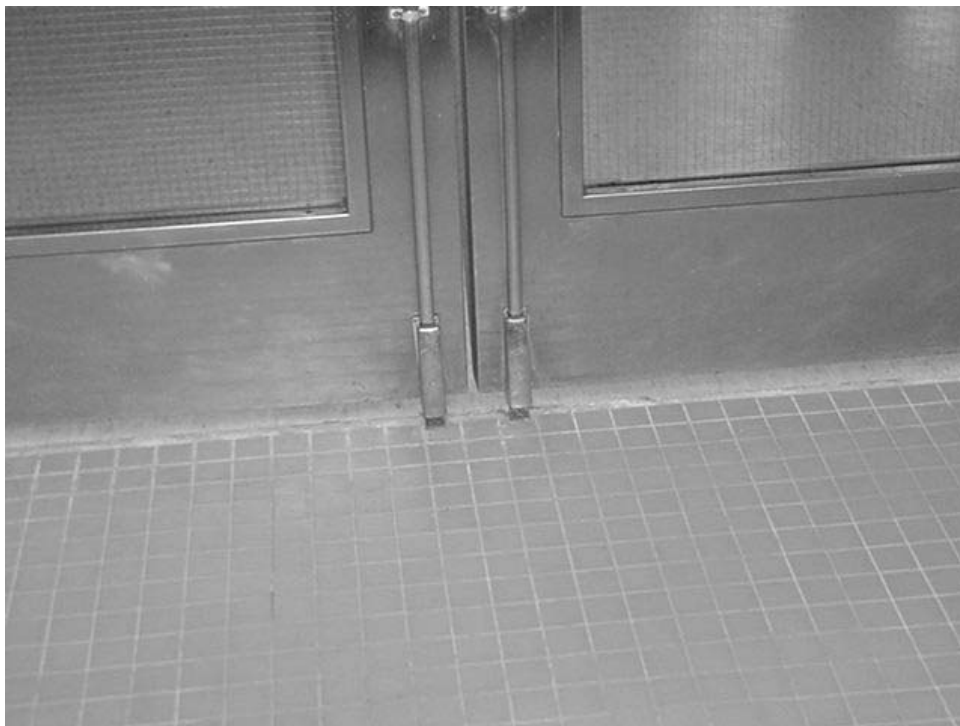
Picture 24

The presence of pool related odors in occupant areas indicates that breaches (i.e. utility holes, cracks) exist, allowing movement of odors to areas surrounding the pool. The

pool room, adjacent hallway and stairwell should be examined for odor pathways and be sealed and/or stopped to prevent movement and penetration of odors to adjacent areas. For example, door sweeps should be placed on the doors leading to the pool area to prevent movement of odors into the hallway and stairwell (Picture 24). At the time of the assessment, doors in the hallway leading to the pool room were propped open; these doors should remain closed to prevent the migration of odors into hallways.

Door between pool room and foyer, note spaces around door

16. Install door sweeps to doors leading to/from the pool area. Ensure these doors are closed to prevent movement of odors.
17. Clean upholstered furniture to prevent buildup of irritants. Consider vacuuming with a HEPA filter equipped vacuum and wet washing/wiping to reduce dust, dander, and allergens/asthmagens.
18. Consider adopting the US EPA (2000b) document, “Tools for Schools”, to maintain a good indoor air quality environment in the building. This document can be downloaded from the Internet at <http://www.epa.gov/iaq/schools/index.html>.
19. Refer to resource manuals and other related indoor air quality documents for additional building-wide evaluations and advice on maintaining public buildings.
